# Manhole Inspection Summary

Manhole # S35A\_\_018MH

Insp Date: **8/6/08 3:42 PM**

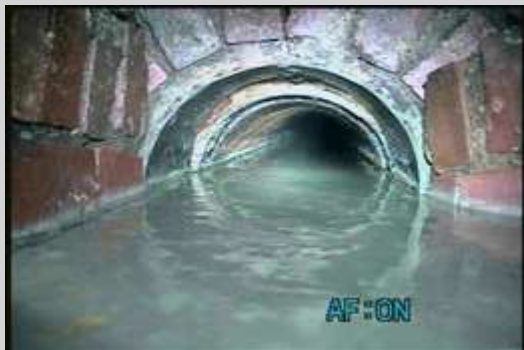
12 O'Clock Outflow

10 in. Circular Gravity Sewer  
Pipe Out @ 12 O'Clock

Pipe Material: Clay ☐ Pipe Lined

Invert Depth: 9.75 (ft.) Flow Characteristics: Slow

Deposits: ☒ None ☐ Mud ☐ Sludge ☐ Debris ☐ Grease

Infiltration: None Pipe Seal Cond: Unknown

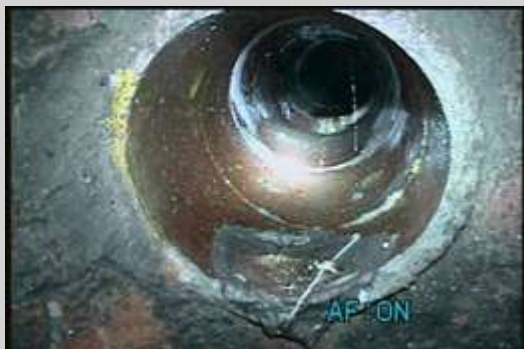
3 O'Clock Inflow

8 in. Circular Gravity Sewer  
Pipe In @ 3 O'Clock

Pipe Material: Clay ☐ Pipe Lined

Invert Depth: 8.00 (ft.) Flow Characteristics: Slow

Deposits: ☒ None ☐ Mud ☐ Sludge ☐ Debris ☐ Grease

Infiltration: None Pipe Seal Cond: Unknown

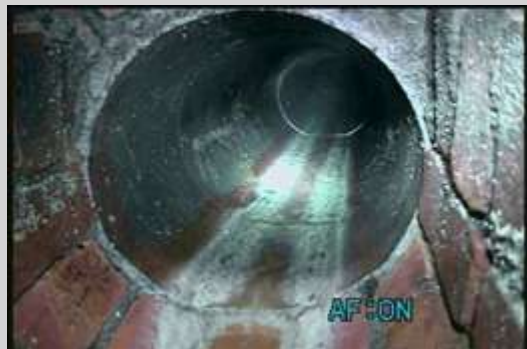
6 O'Clock Inflow

10 in. Circular Gravity Sewer  
Pipe In @ 6 O'Clock

Pipe Material: **Clay** ☐ Pipe Lined

Infiltration: **None** Pipe Seal Cond: **Unknown**
